# **Evaluation of the Dober Mine Synergetic Acid Water Treatment System**

**10 March 2005**

# Evaluation of the Dober Mine Synergetic Acid Water Treatment System

**Report:** Allan M. Johnson, Ph.D., Mining/Geological Engineering Consultant  
Kent Premo, M.S., Technical Support Scientist  
David Tiller, Field Scientist  
Bette Premo, Ph.D., Project Manager

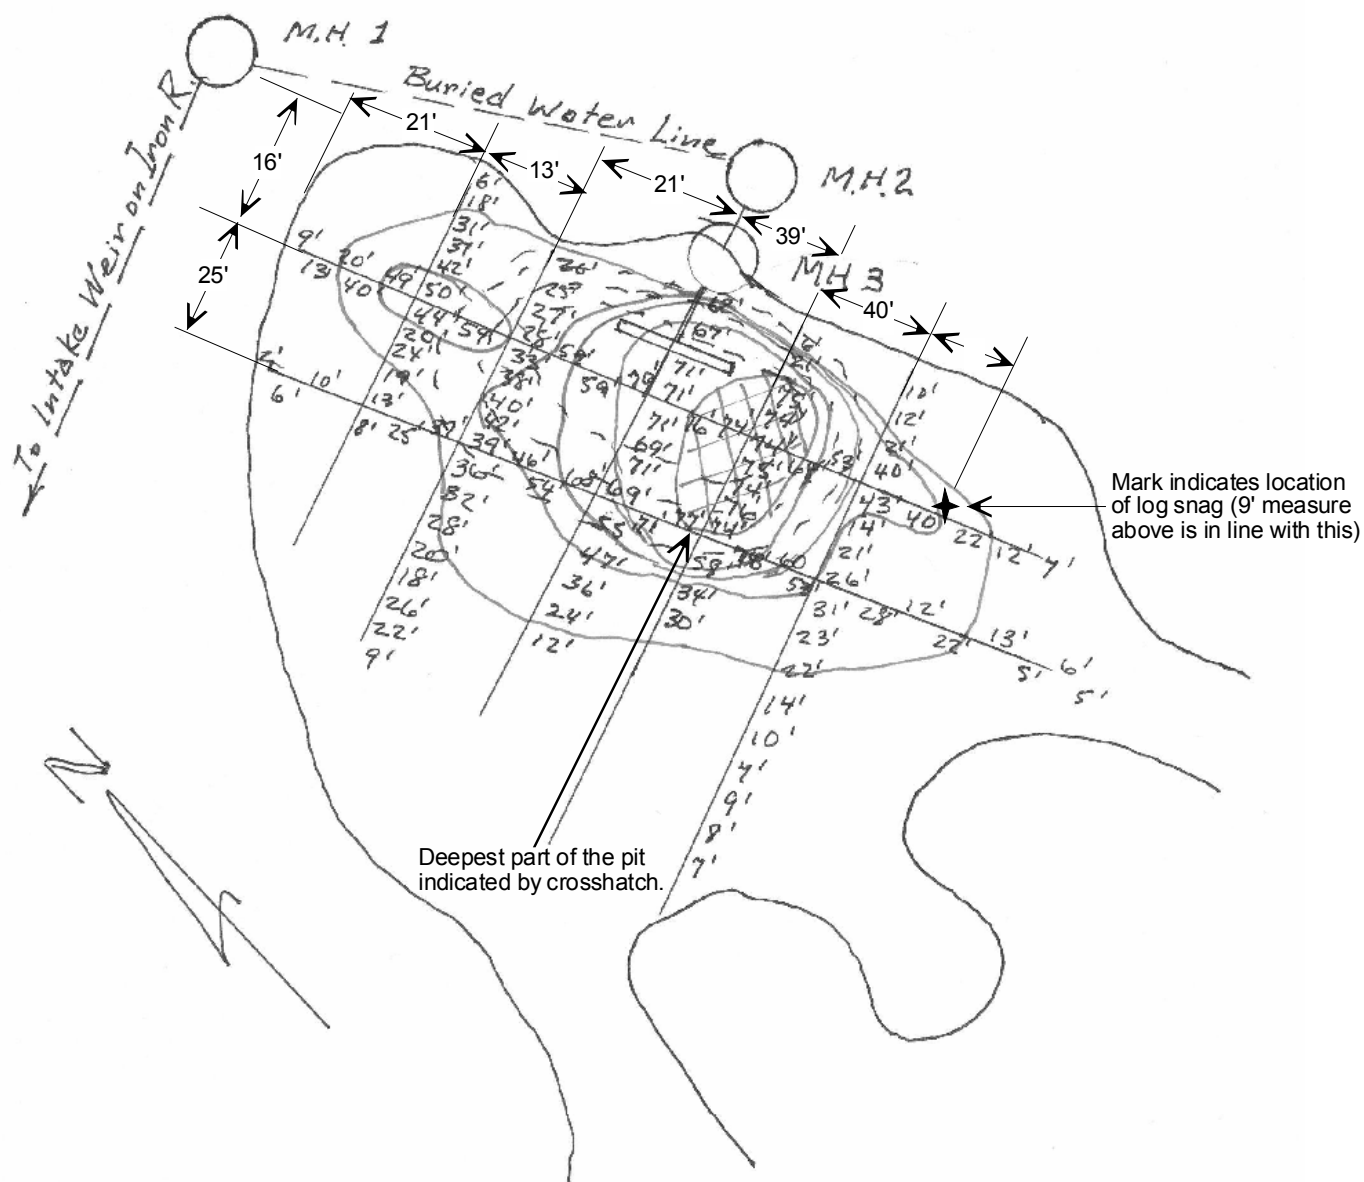
Figure 6. Depth Profile of Dober Mine Pit Conducted on 10 November 2005

It was observed that an apparently firm bottom was present in the vicinity of the river discharge header at the depth of approximately 70 feet. It should be kept in mind that the Dober pit was initially an open pit mine and that open stopes (mined openings) were caved to the 10th level, although significant sand filling was also done to stabilize the mine and to extinguish mine fires. Also it should be kept in mind that the Number 1 and 2 shafts are situated adjacent to the Dober pit and would be connected with stopes on the lower levels via drifts. Thus there are many paths that the upwelling acid waters can follow within the “plumbing system” of the mine to reach the surface.

During the sonar profiling of the Dober pit on 10 November, it was noted that there was one spot in the pit where erratic readings were observed. This occurred near the southeast part of the pit above formerly open stopes in the Dober mine. The readings at this spot showed rapidly changing depths ranging from tens of feet to depths of more than 80 feet. At the time, it was believed that the sonar unit was malfunctioning. However, in retrospect, it was thought that the readings may have detected the inflow point for mine water and that the erratic readings might be representing plumes of iron hydroxide precipitate being carried up by a higher velocity current of mine water entering the pit through a small opening or series of openings. Consequently, it was deemed important to check out this possibility before winter conditions settled in and the work could not be done without great difficulty.

Late in the day on 23 November, after other tasks were completed, a 12 foot aluminum rowboat was put into the Dober mine pit for a second sounding. An attempt was made to locate the zone where erratic readings were previously observed using the sonar device. The suspect area was passed over a number of times with the sonar unit, without being able to reproduce the earlier erratic readings.

Next a water level measuring device with 200 feet of tape marked in feet was used to sound the suspect area. After several attempts, the weighted signal device at the tape's end fed freely to the limit of the tape. As the maximum depth in the pit had been determined to be about 80 feet deep earlier in the month, this seemed to indicate that an opening or channel way had been found into the mine through which mine water was believed to be entering the pit. However, when the larger diameter Kemmerer sampler was lowered in the same general area to obtain a sample of the suspected acid water we were unable to relocate this channel way. As it was near the end of the daylight period, we were unable to pursue this activity to the extent desired and had to end this quest without a satisfactory resolution. However, two bottom samples were taken from this site with the Kemmerer device. They were both dark colored precipitate-filled samples of brownish iron hydroxide hydrate, but not the anticipated upwelling clear acid mine water.

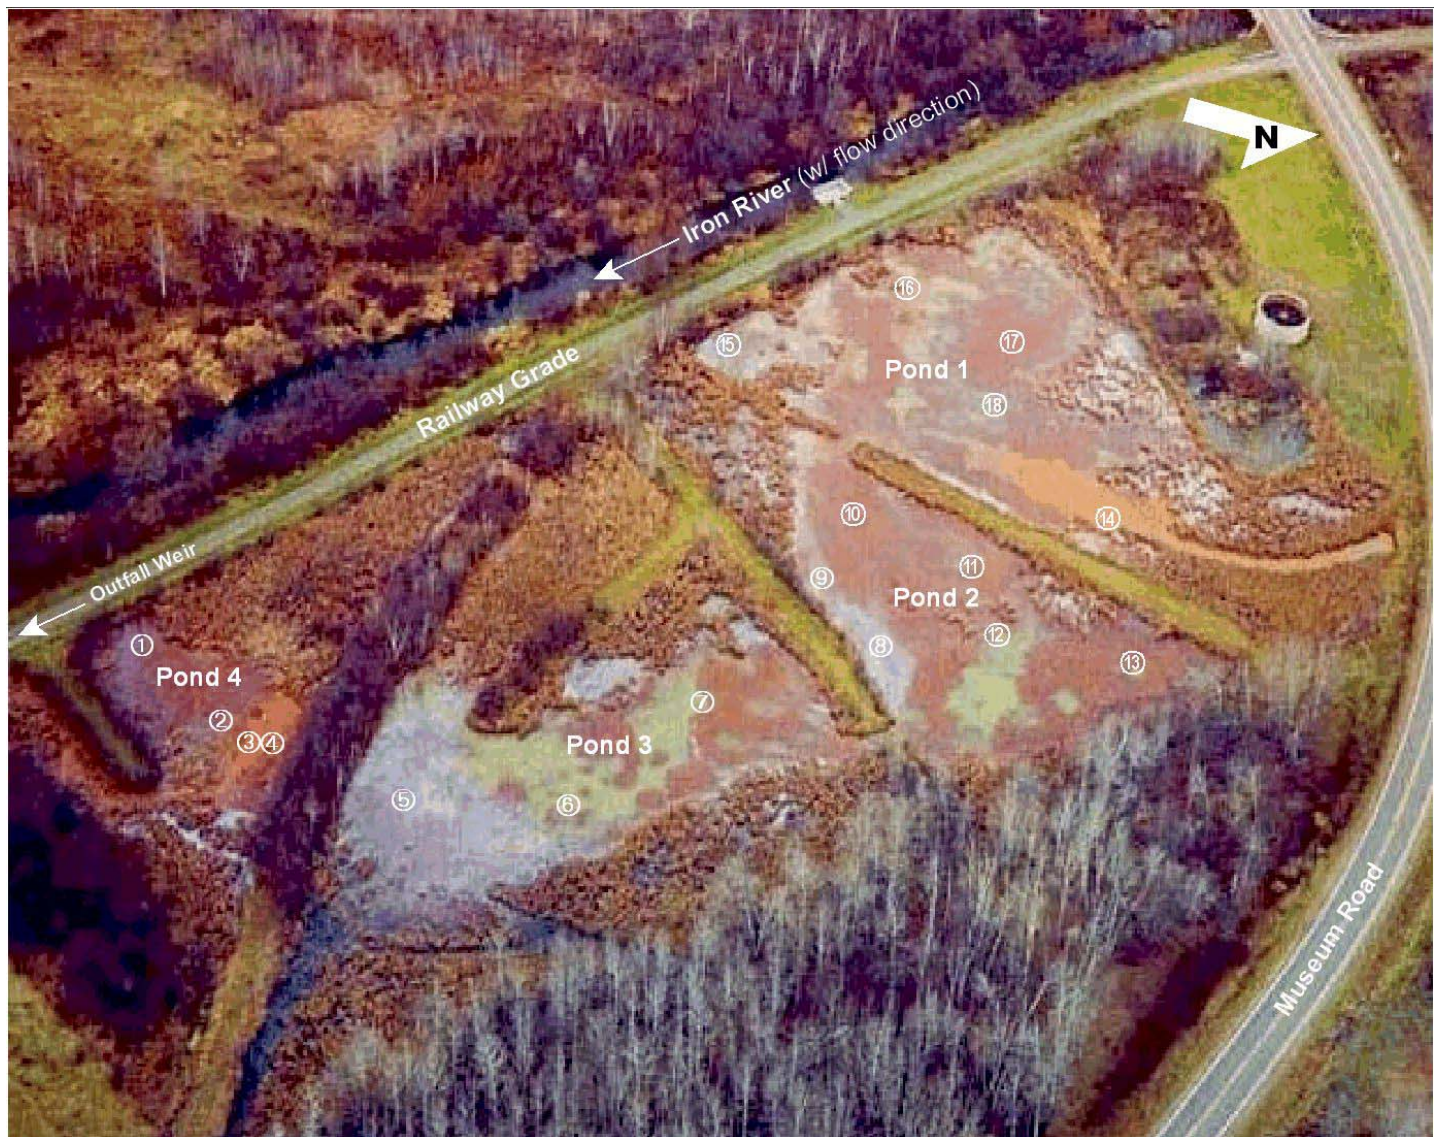
Figure 7. Aerial Photo View of Dober Mine Settling Ponds with Ice Auger Locations

covered, but not completely frozen to the bottom. The first open water was encountered in the narrow channel between the 2nd and 3rd ponds. Here the current was strong enough so that ice did not form. On the 2nd pond, the ice was much thinner and in some places unsafe to walk on. Also, water had flooded the ice over part of the 2nd pond to a depth of from one-half to 2 inches. The 1st pond which received water from the channel coming from the Dober pit had an extensive area of open water in the main flow channel of this pond. Thicker ice was present in areas of the pond away from the channel. A total of 18 holes were bored in the four ponds and the water and sediment columns examined. These data are presented in Table 3.

From Table 3 it can be seen that most of the precipitation of yellow boy takes place in Pond 1 and Pond 2. A small amount is seen to have been precipitated in Pond 3, from the sediment column data. The small Pond 4 showed no yellow boy precipitate in the sediment column. These data suggest that, even though the ponds are in places choked with cattails and that channeling of water is occurring, significant settling of iron hydroxide precipitates does occur in the pond system even in the dead of winter under very cold conditions.

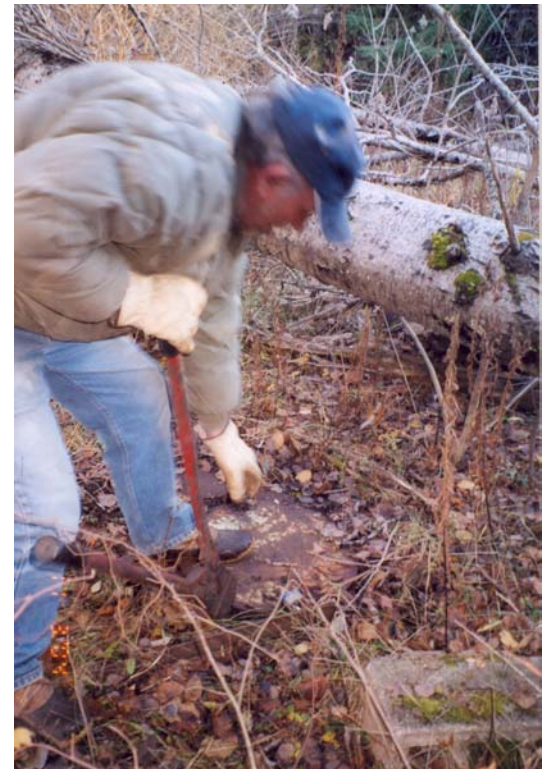
Photo 8 (bottom right). Tiller removing old lock at CDH 2-45 Hiawatha #1 mine, 3 November 2004

7. The steel plate holding the locking cover over CDH 2-45 should be fastened securely to its concrete base to make the 10-inch drilled hole safe for any who might be attracted to this site. The mine water lies 60 feet below the concrete plug in the churn drill hole and is at least 300 feet deep. The steel plate was at one time secure, but is now loose. Warning signs should be prominently posted and the Iron County Mine Inspector should be aware of the site and include in future inspections.

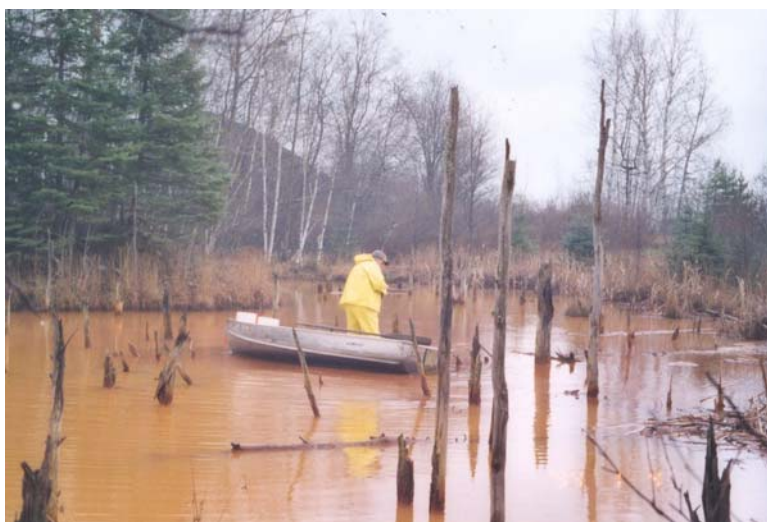
Photo 10 (middle right). Tiller entering Dober mine pit from dead snag clogged outflow channel, 10 November 2004

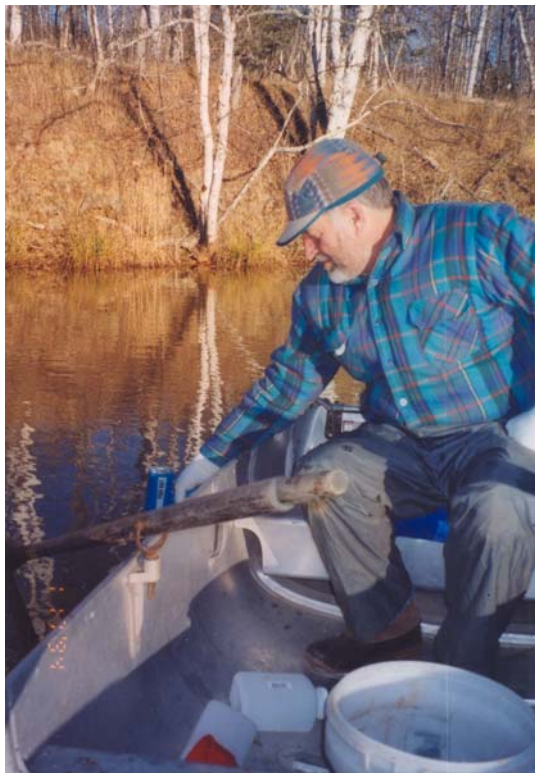
Photo 13 (middle right). Tiller with yellow boy sample taken from 75 foot depth in Dober mine pit, 23 November 2004
