# **Evaluation of the Dober Mine Synergetic Acid Water Treatment System**

**10 March 2005**

# Evaluation of the Dober Mine Synergetic Acid Water Treatment System

**Report:** Allan M. Johnson, Ph.D., Mining/Geological Engineering Consultant  
Kent Premo, M.S., Technical Support Scientist  
David Tiller, Field Scientist  
Bette Premo, Ph.D., Project Manager

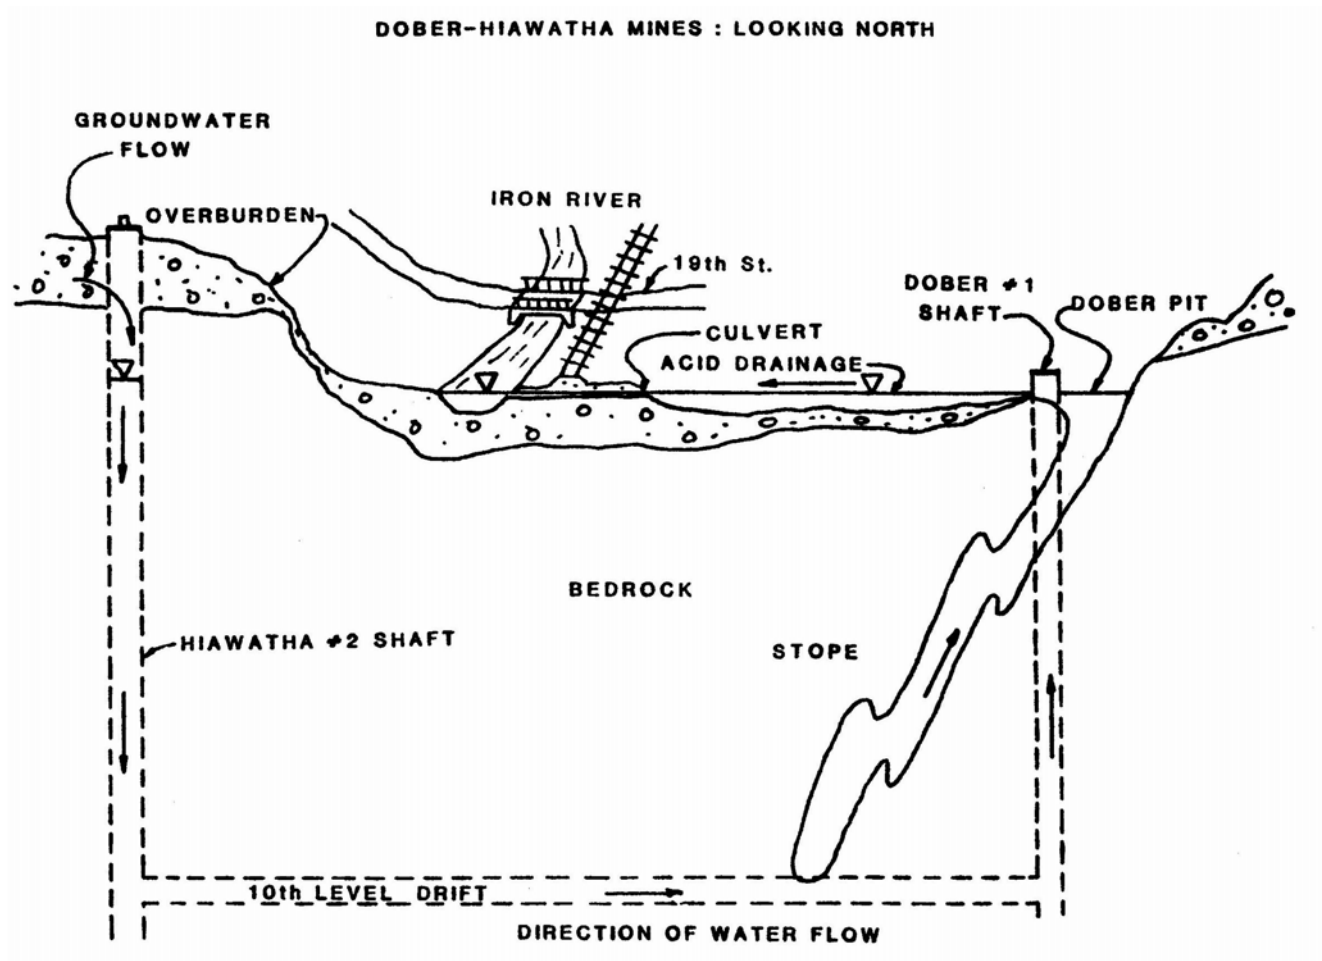
Figure 4. Schematic Representation of Acid Water Flow from the Dober Mine Complex

The Dober mine pit exists because the first mining was done by open pit methods. Because the Dober ore body is lenticular and dips 65 degrees to the southwest the open pit could only be operated to about the 3rd level of the mine some 300 feet deep. Mining continued via shafts on both sides of the pit. Early mine maps show the Dober No. 1 vertical shaft on the north side of the pit has 10 levels to a depth of 980 feet and the inclined No. 2 shaft, southeast of the pit dips 65 degrees southwesterly to follow the dip of the ore body as far as the 9th level (Figure 4).

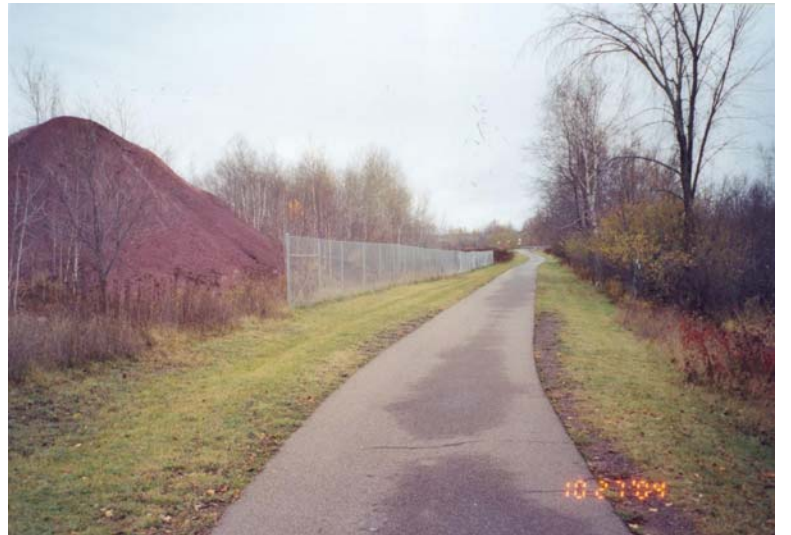
Photo 3 (middle right). Looking east along Apple Blossom Walking Trail, Dober mine waste rock pile to left and Iron River on the right, 27 October 2004

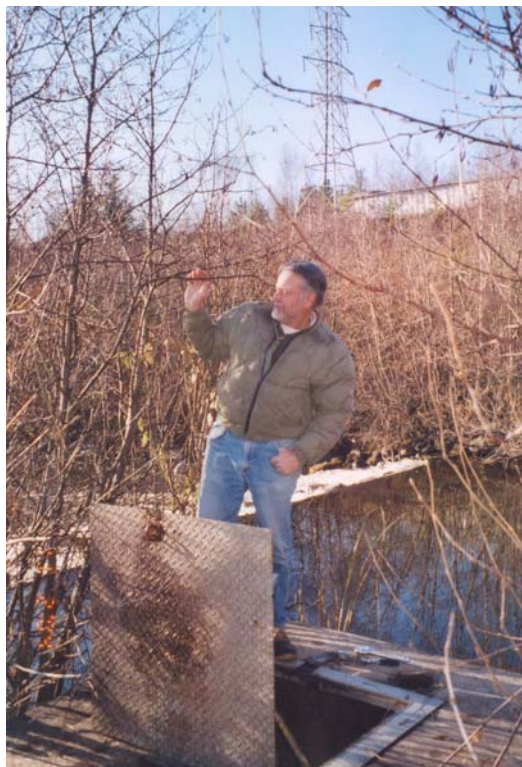
Photo 10 (middle right). Tiller entering Dober mine pit from dead snag clogged outflow channel, 10 November 2004

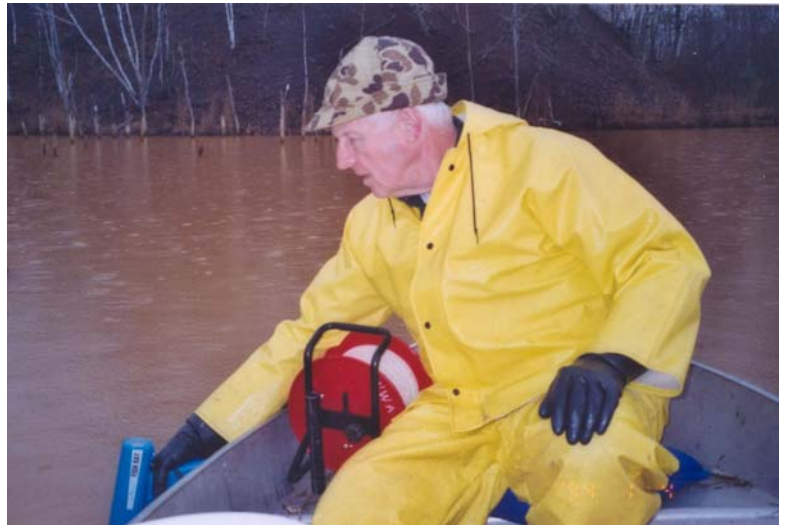
Photo 13 (middle right). Tiller with yellow boy sample taken from 75 foot depth in Dober mine pit, 23 November 2004

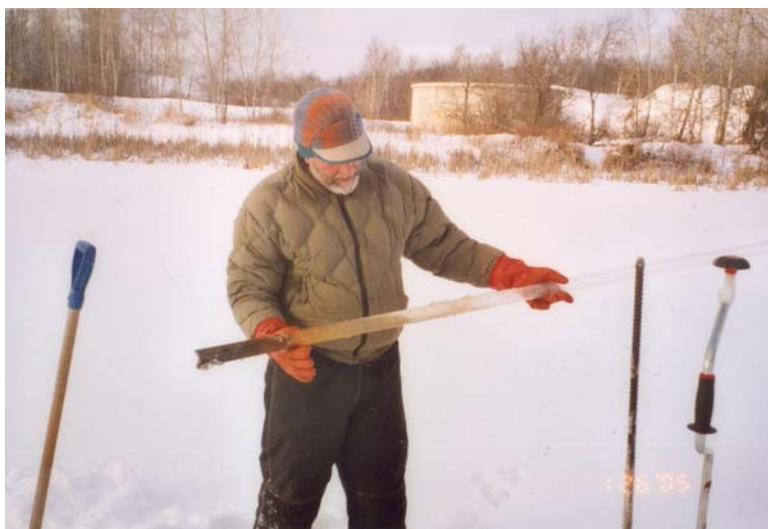
Photo 18 (bottom right). Tiller holding sediment tube with yellow boy sample, pond #1, Dober Mine Synergetic Acid Water Treatment System, 26 January 2005
